Investigation of Deterioration of Joints in Concrete Pavements

National Concrete Pavement
Technology Center

Final Report
August 2012

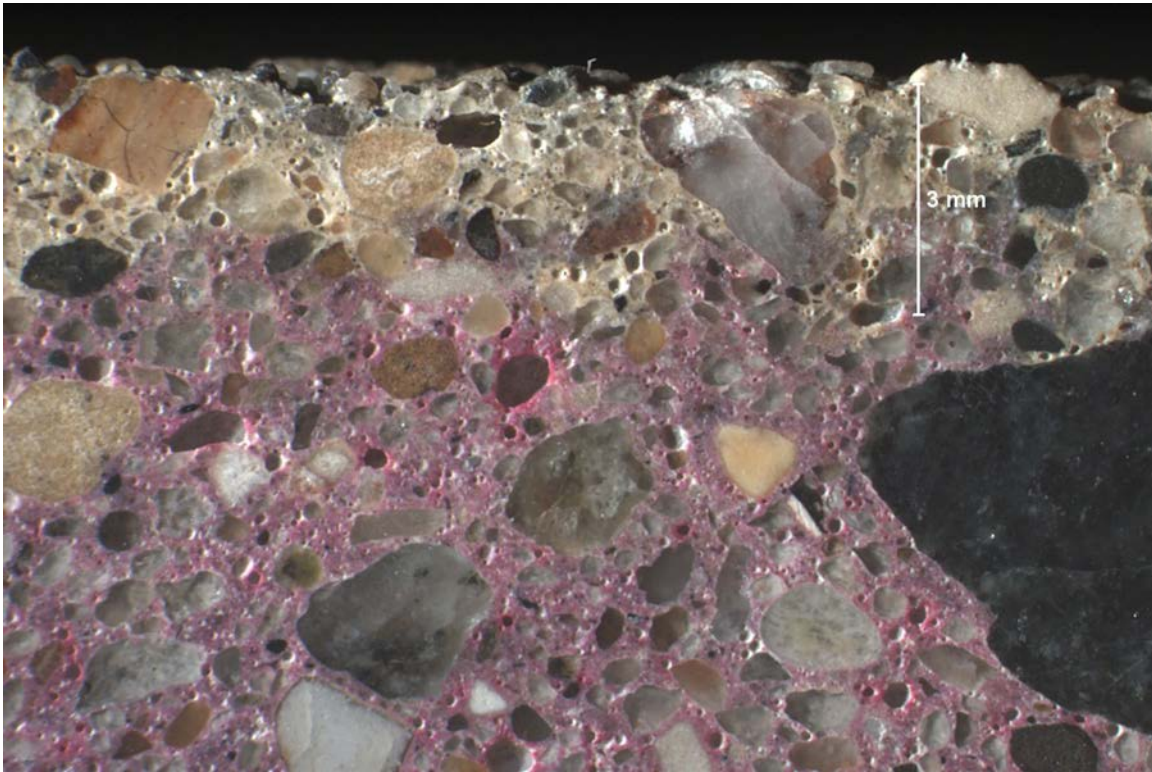
PHOTO: 29

SAMPLE ID: 4, 4705-30 **DESCRIPTION:** Carbonation (unstained paste) proceeds up to 3mm depth (in this image) from the top surface of the core.

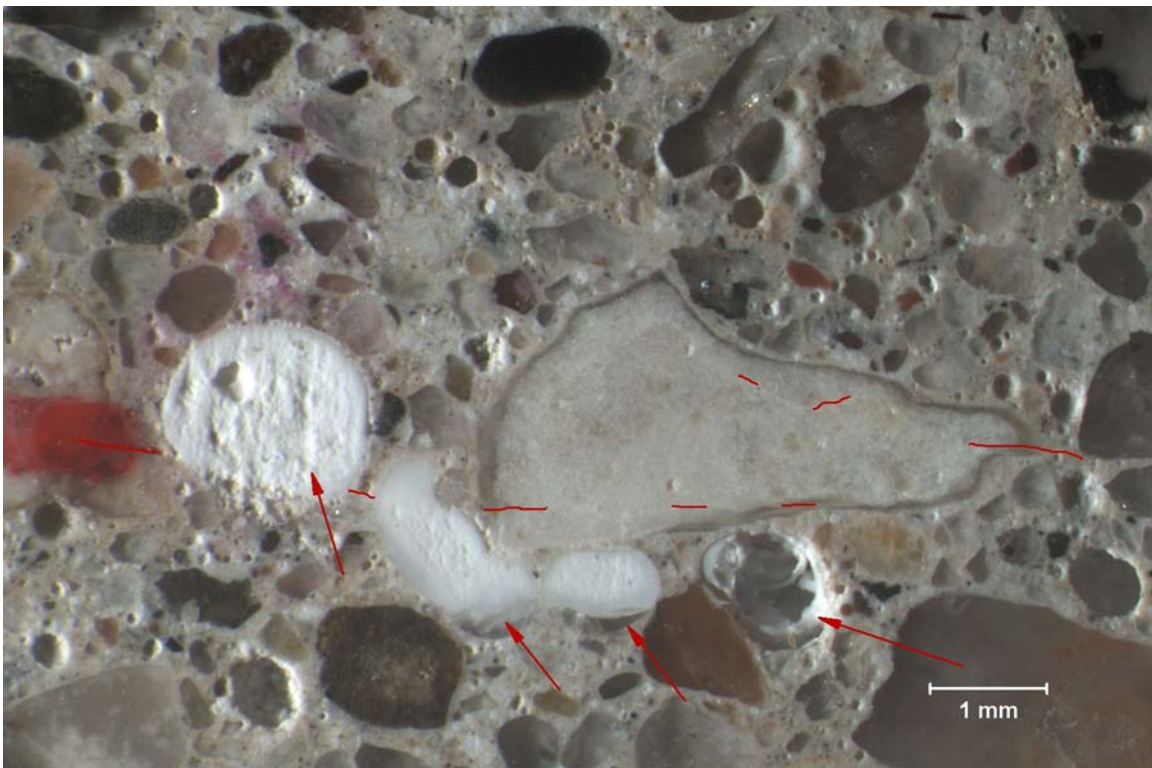
PHOTO: 30

SAMPLE ID: 4, 4705-30 **DESCRIPTION:** White to clear ASR gel product lines or fills voidspace adjacent to a reactive chert fine aggregate particle. Internal and radiating microcracking is mapped in red dashed lines.

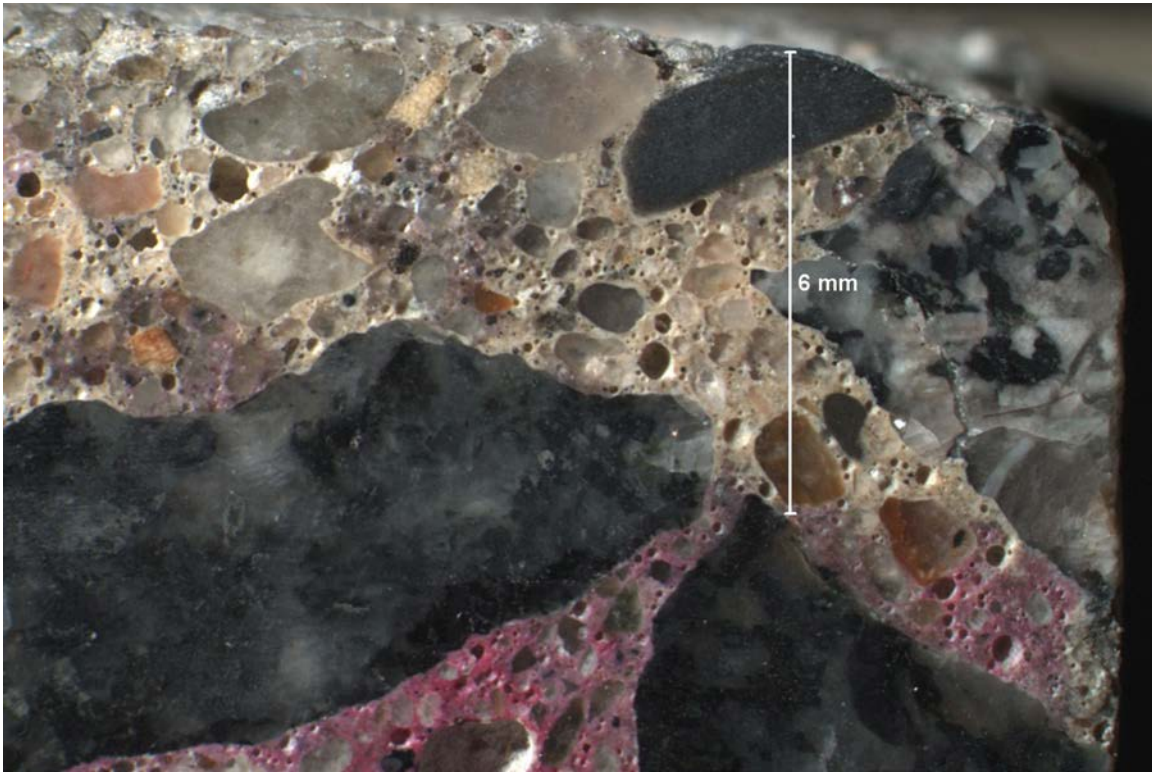
PHOTO: 33

SAMPLE ID: 7, 4705-30 **DESCRIPTION:** Carbonation (unstained paste) proceeds up to 6mm depth from the top surface of the core.
MAG: 5x

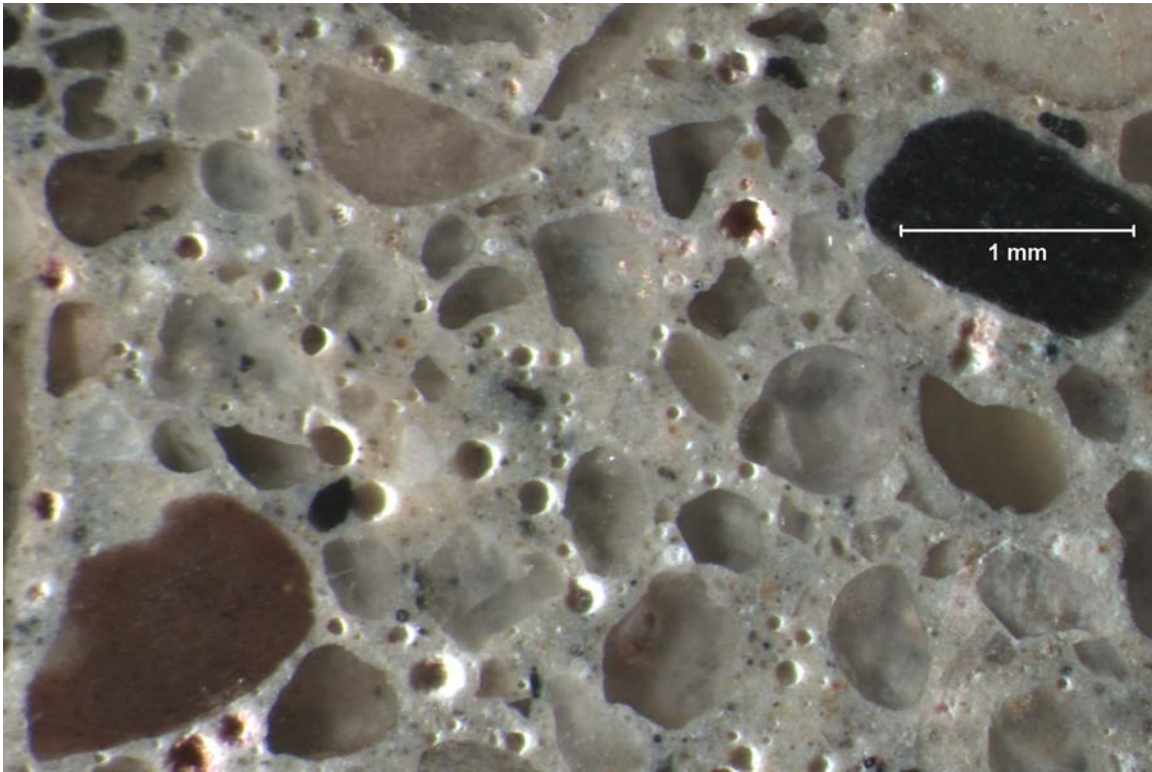
PHOTO: 35

SAMPLE ID: 7, 4705-30 **DESCRIPTION:** Overall view of the air void system at 112mm depth from the top surface of the core and 40mm depth from the joint plane.

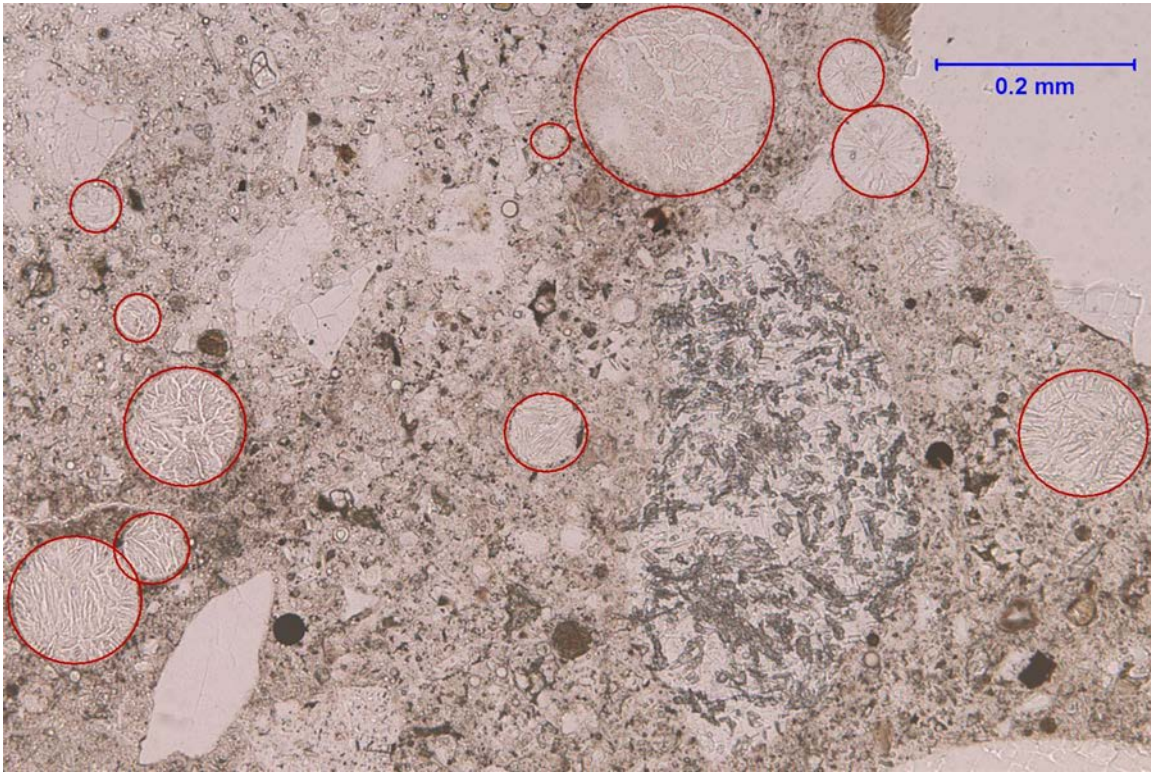
PHOTO: 37

SAMPLE ID: 7, 4705-30 **DESCRIPTION:** Ettringite-filled voidspaces (outlined in red) in the paste proximate to the joint plane in thin section under plane polarized light.

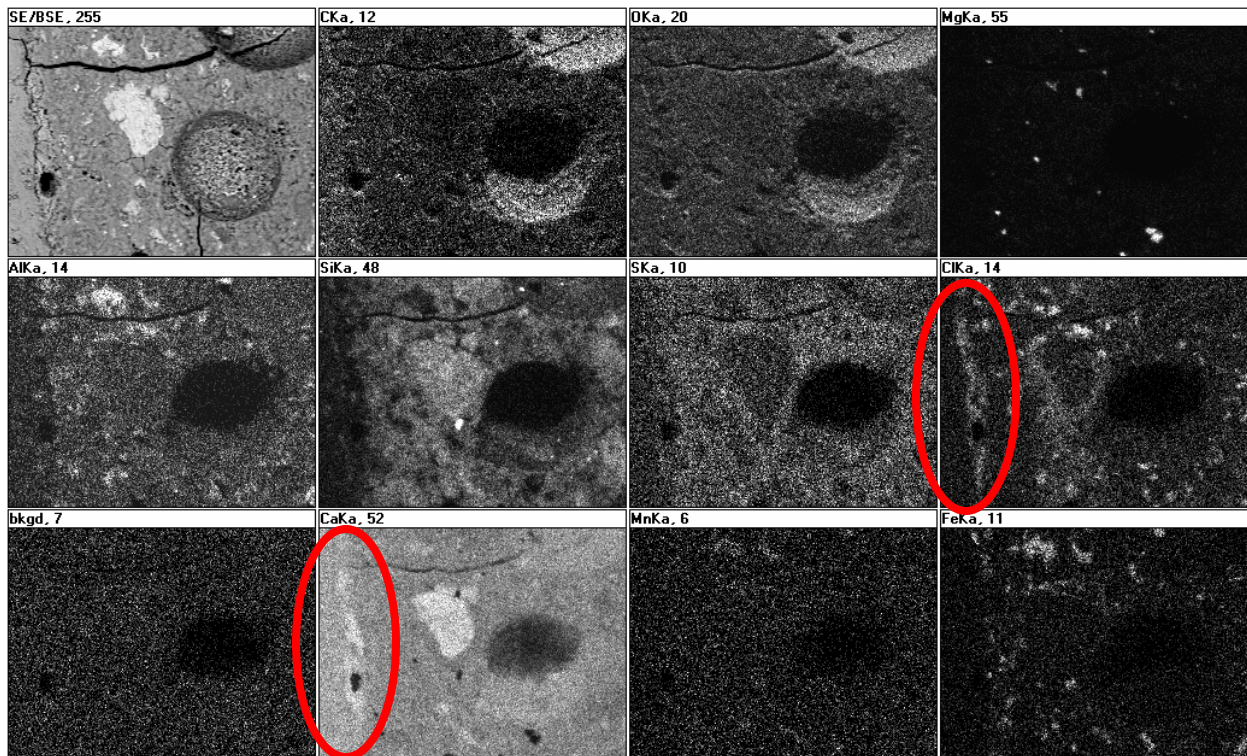
Figure 3. SEM analysis on distressed samples under cyclic freeze thaw in CaCl2 solution

The original external face of the sample is horizontal and about 3/8 in. above the top of the image. The field of view is about 400µm. A coarse aggregate particle is visible to the left of the image.

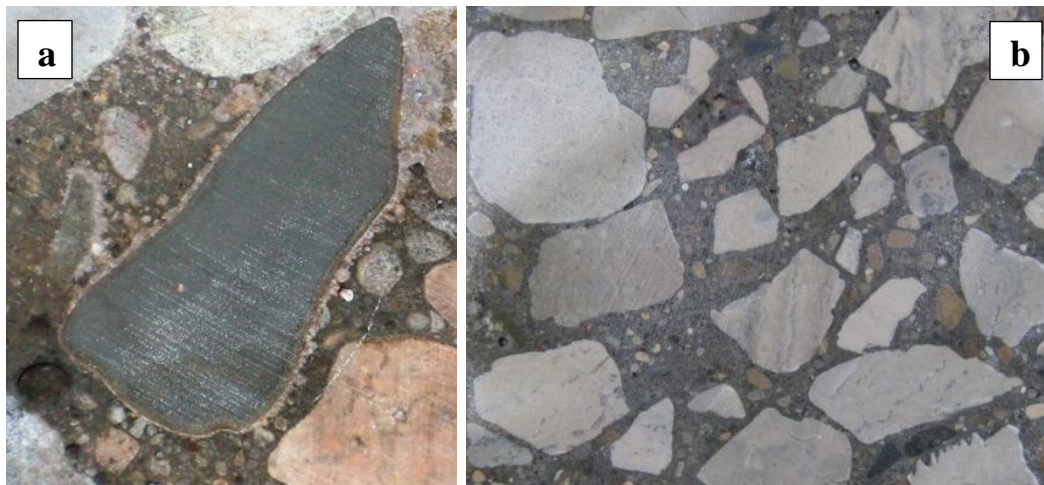
Figure 10. Samples tested in salt, cut, then treated with silver nitrate to highlight presence of chlorides (a) 0.5 - 0%SF - gravel (b) 0.4 - 5%SF - limestone

The samples treated with silver nitrate showed a white ring around some of the aggregate particles. This seems to indicate that the salt solution preferentially penetrated into the concrete through the interfacial zone. The limestone aggregates show fewer rings than the sample made with gravel. The sample mixed with gravel also had a higher w/cm without any silica fume.

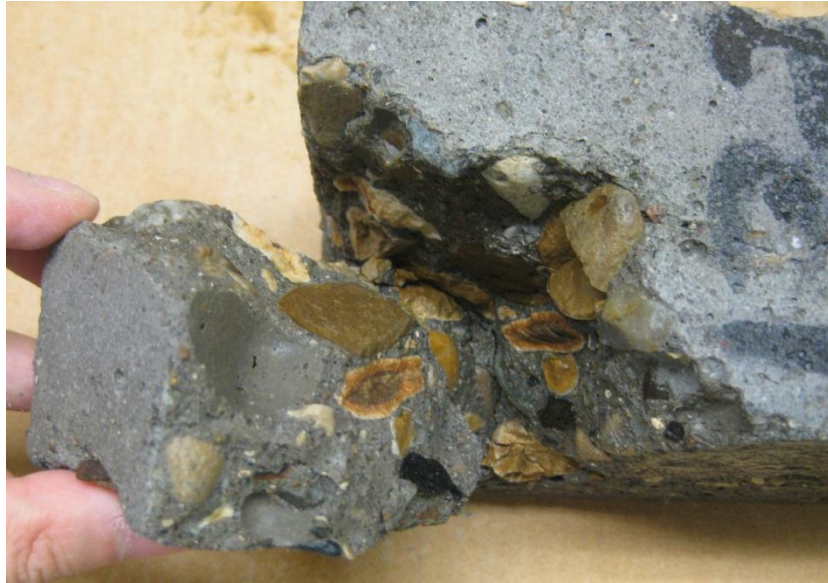
Figure 11. Laboratory observation of distress incurred during freezing and thawing

All are factors likely leading to a more dominant interfacial zone. As an example, some typical distress is shown in Figure 11 with damage to a sample containing gravel, $w/cm = 0.5$, and 5% silica fume (SF).

The failure surface includes both cracks through and around aggregate particles. Failures around the aggregates are likely associated with the ITZ because it is normally unusual to see aggregate particles without paste adhering to them, unless the mechanism of stress is adjacent to the surface.
